World Oil[®] HPHT
DRILLING, COMPLETIONS & PRODUCTION CONFERENCE

Innovative Subsea Shear Joint System

Mitchell Dziekonski
Vice President
ALTISS Technologies

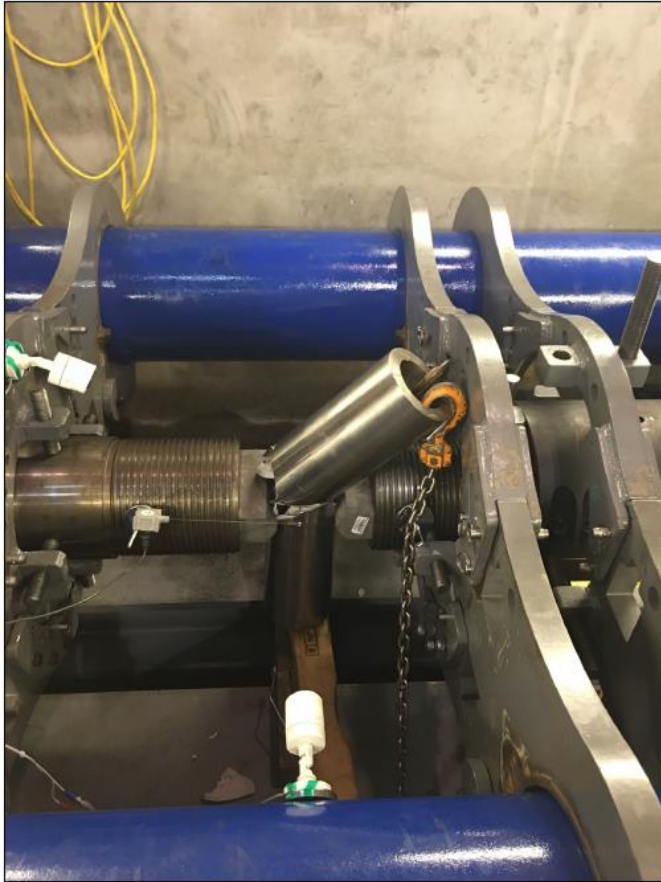
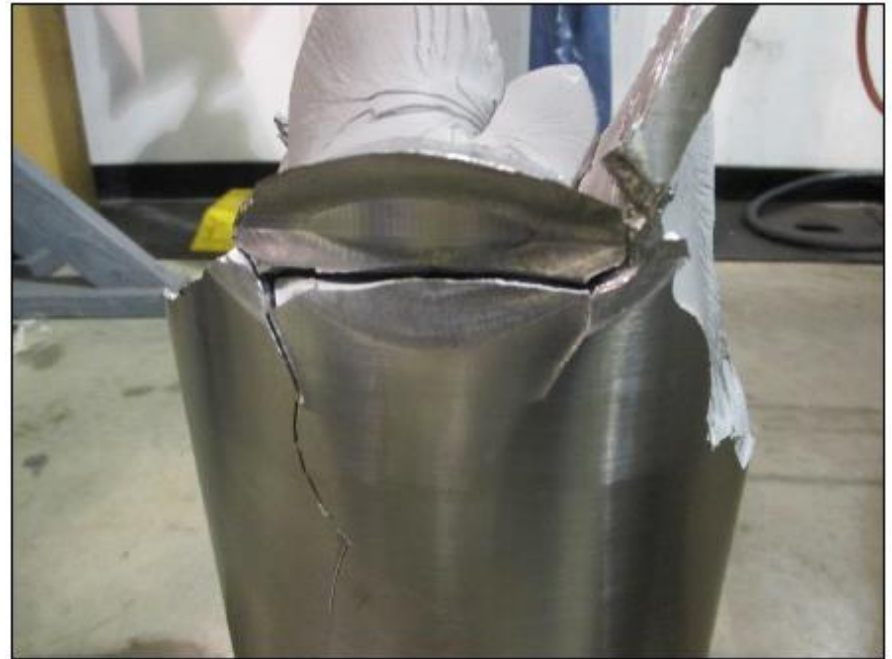
Titanium Shear Test

Sheared at Much Lower Force
Correlated with FEA Study
