**World Oil<sup>®</sup> HPHT**  
**DRILLING, COMPLETIONS & PRODUCTION CONFERENCE**

# Qualification of High Pressure, High Temperature Threaded and Coupled Workover/Completion Riser

Vallourec

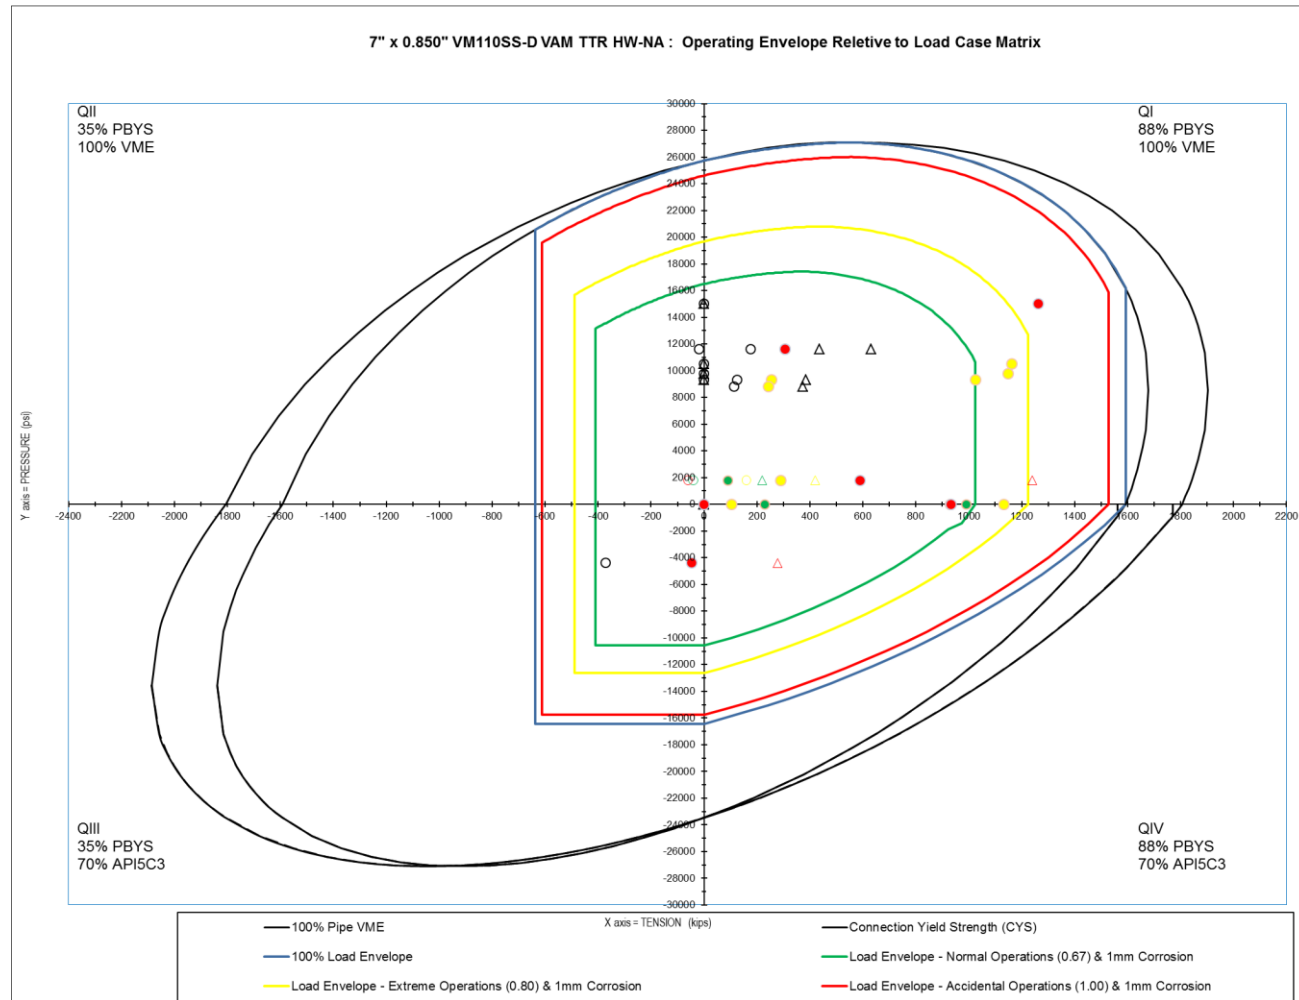
- An envelope of the selected connection was created showing the different levels of operating, extreme, and accidental loads.
- The various loads were then plotted against the Von Mises Ellipse to ensure all loads fell within the allowable envelopes

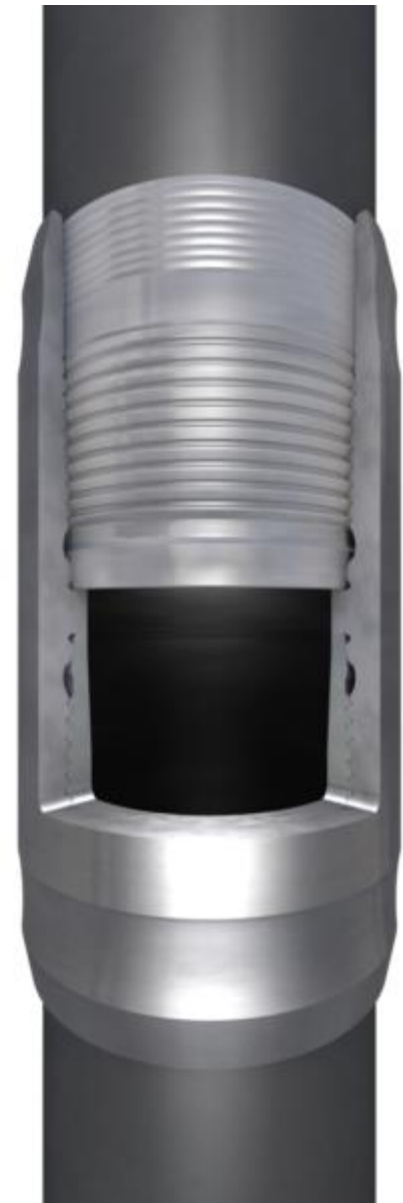
- Connection Selection
  - VAM® TTR was selected to meet the connection requirements.
  - The high fatigue performance and internal/external metal to metal seal met all of the environmental and performance criteria
  - Strong field history also made it a good option for the end user

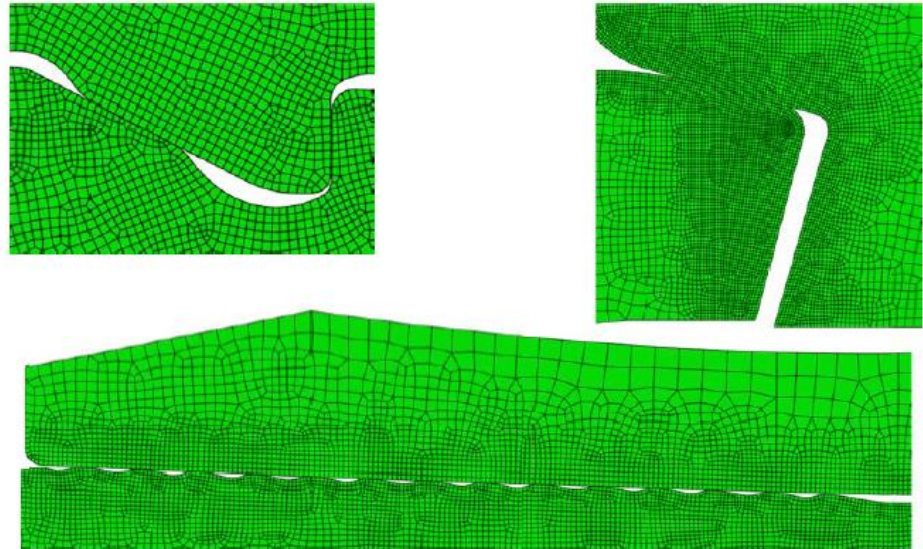
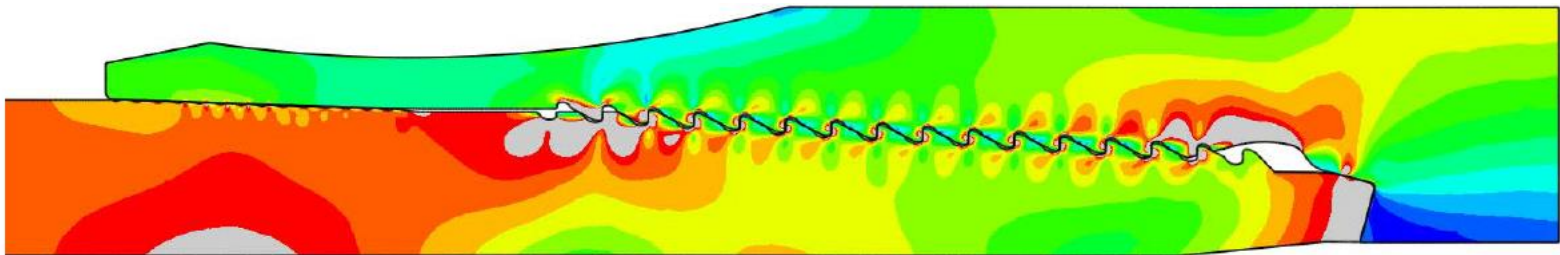
- Detailed FEA work showed the connection/pipe met load performance required
- Results of the FEA were compared to previously tested connections to give more confidence in performance prior to testing
- Based on positive comparison the design was able to move into the testing phase

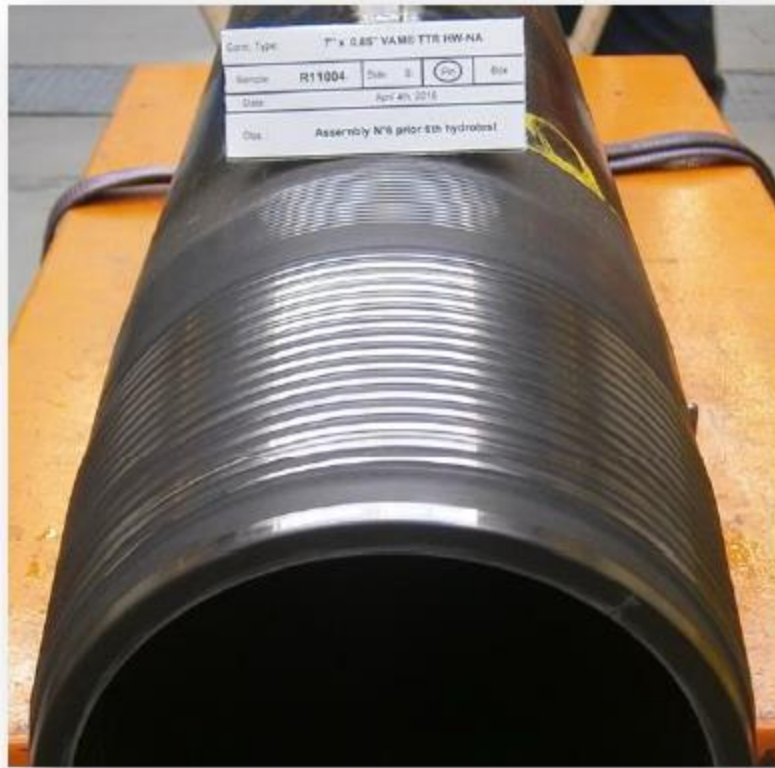
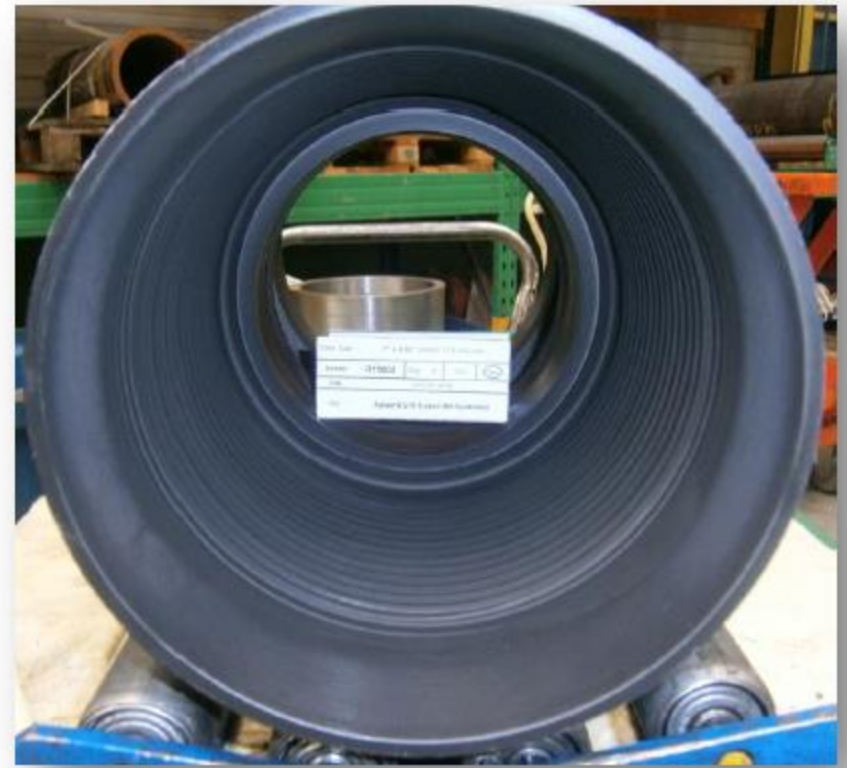
- Make and Break Results
  - 25 M&B Cycles Completed without Galling

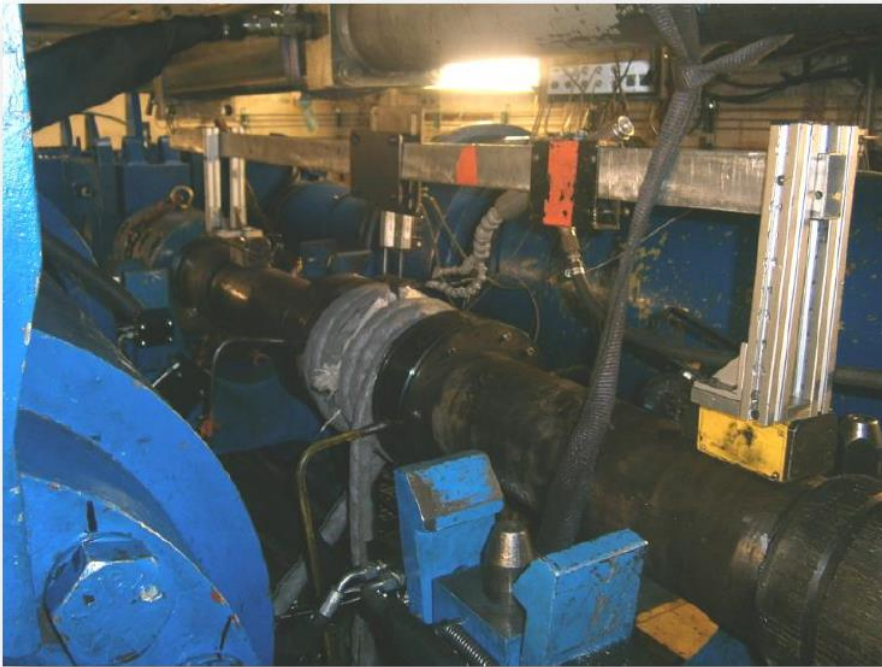
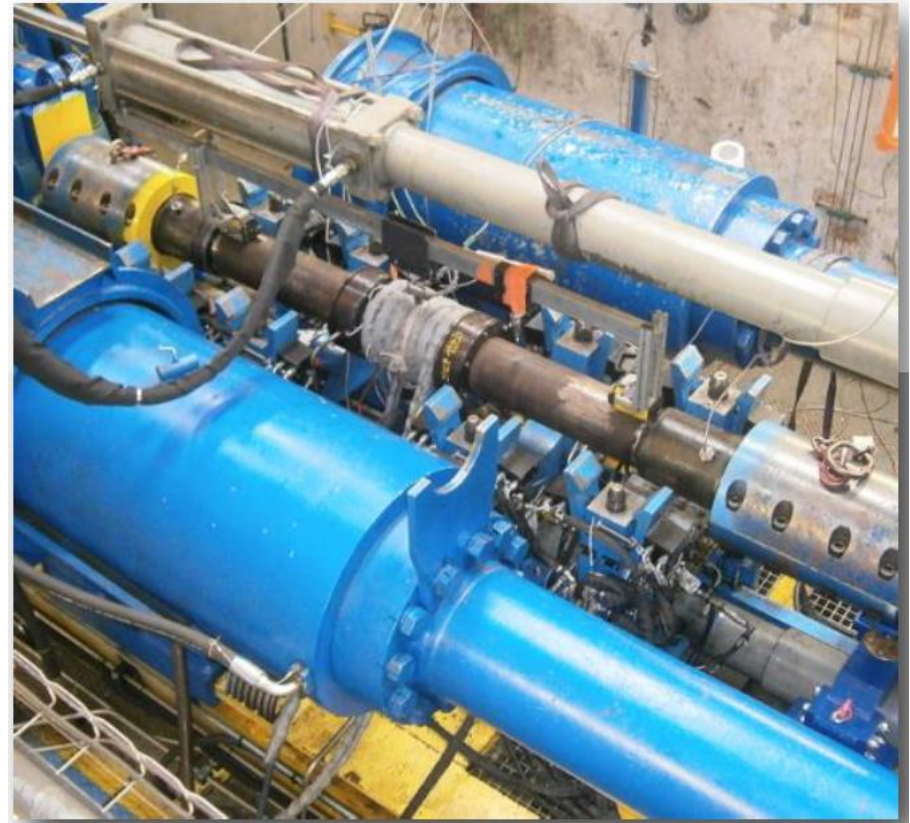
- Sealability Results
  - Combined Load tests completed without leak

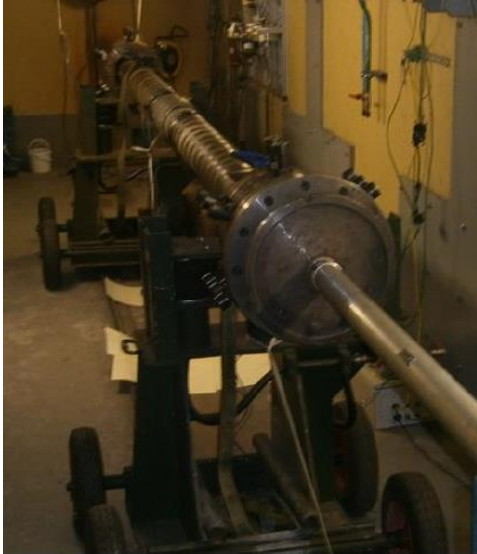
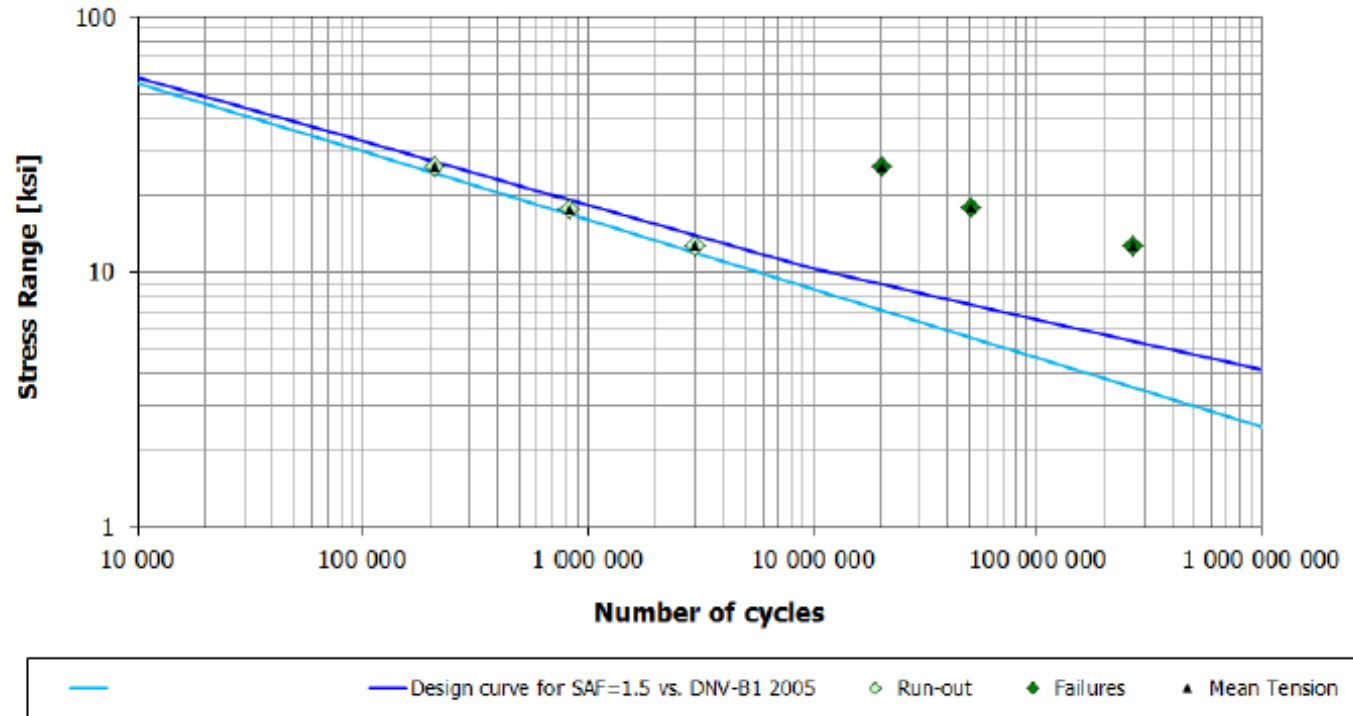
- Fatigue Results
  - High Cycles Achieved

7" 0.85" C110 VAM TTR S-N Data  
including Miner damage for subsequent loads
